# Maryland Historical Trust State Historic Sites Inventory Form

Survey No. CARR-1424

historic George Crouse Tannery ; William Nace Tannery

street & number 2501 Old Fort Schoolhouse Road    not for publication

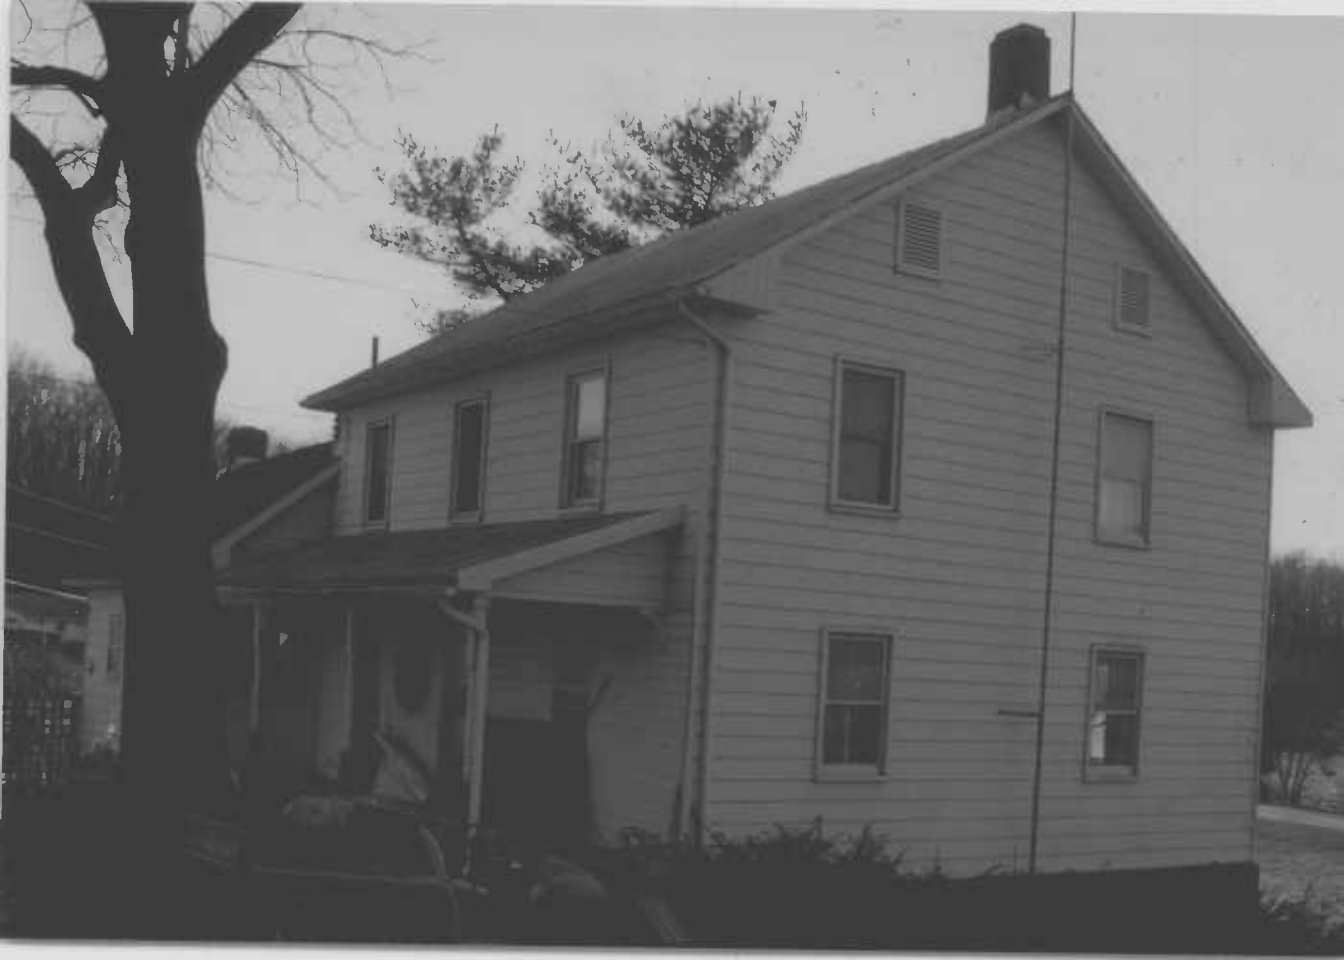
Neg. Loc.: Maryland Historical Trust  
SE : NE elevs.

The house is a two-story, three-bay by two-bay structure with a parged foundation. There is aluminum siding on everything but the southeast elevation first story, which has bevelled novelty siding, and a gable roof of standing-seam metal with a northeast-to-southwest ridge. The house faces southeast toward the old roadbed and is banked on the southeast, with an exposed foundation on the northwest. On the southeast elevation, the first-story south bay has a door with one light over two panels. The panels have sunk fields

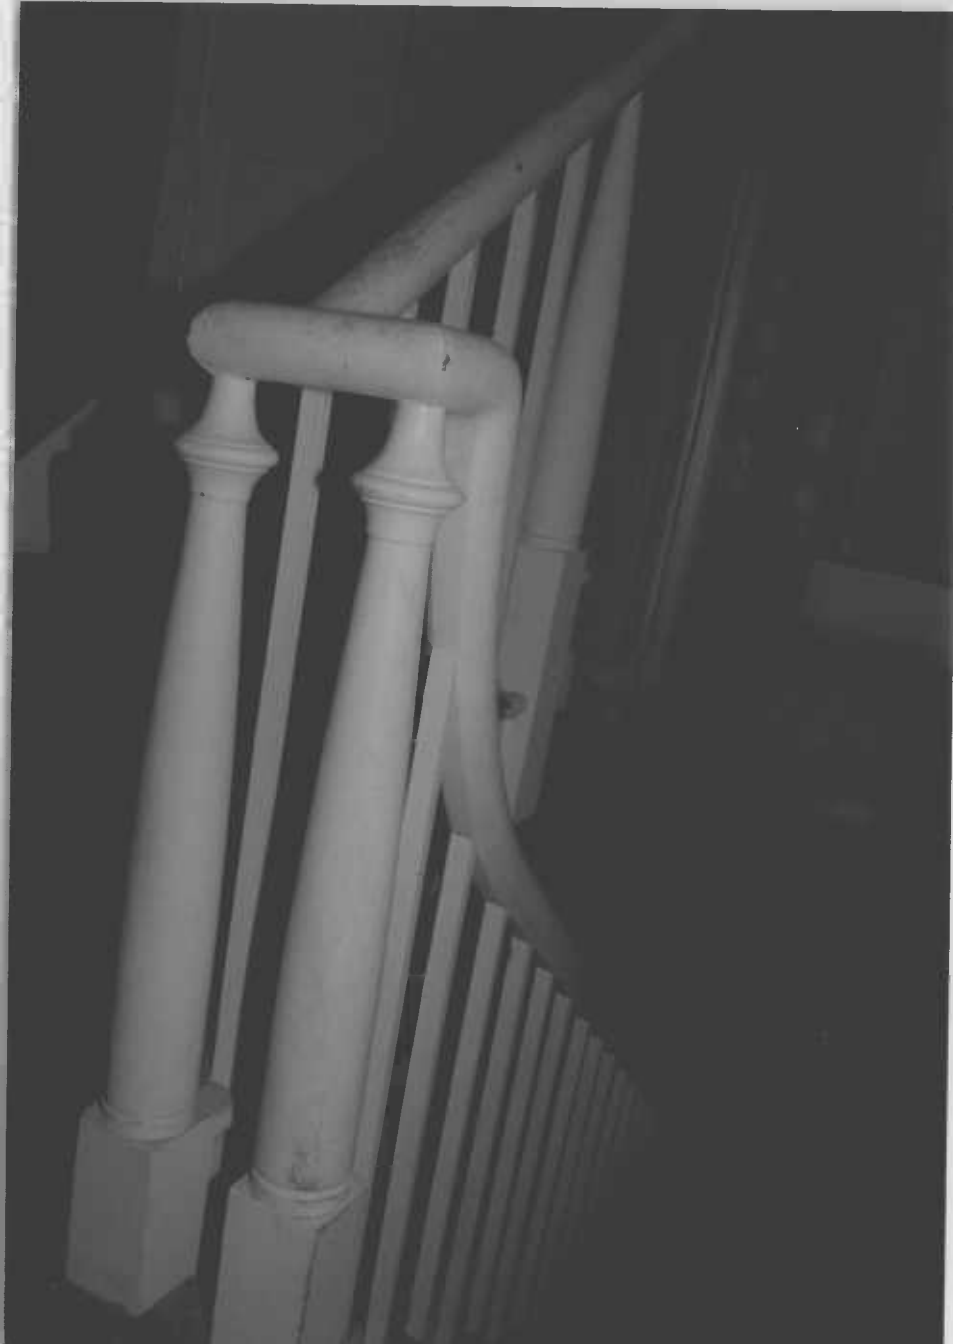
2/3

Stair newel

clearance or head room to get up the stairs. The interior wall here is plastered, and there is probably a winder or a landing at the foot of the stairs. The newel post from the first story passes through the floor in this vicinity. It is 1 inch by 3½ inches and has a wedge through it. There is an opening on the southwest wall of the cellar, to the south, that had a doorway to the exterior, but the frame has been removed. The northwest wall has two boarded-up openings. The northeast wall has one bricked-up opening, and it also has an interior-brick chimney flue. The northeast wall originally had a large fireplace set to the southeast side of the summer beam. There is a header here for the fireplace opening. This space now has circular-sawn infill that is wirenailed, and there are beaded-edge boards.

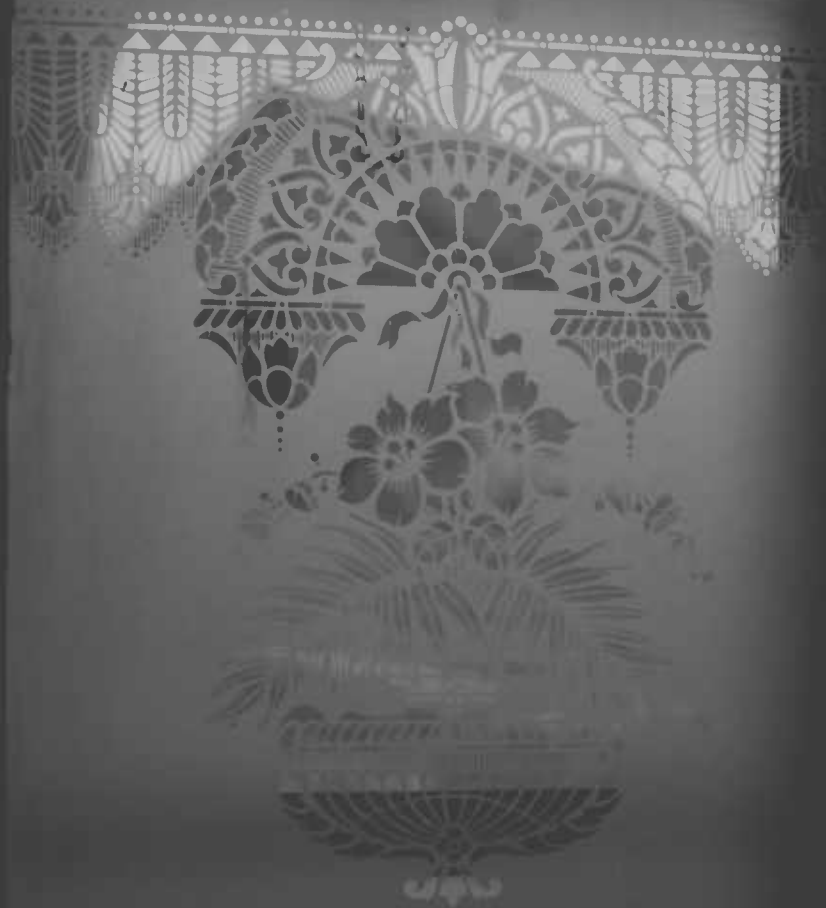
SE elev. door

and steep, quirked ogee panel moulds. The door has a bullnose frame, and there is a four-light transom. The center bay has a door with a beaded interior frame. It has etched glass on the top that has an urn with flowers and a geometric pattern above it. There is a one-light transom. The door has two panels with sunk fields and ovolo panel moulds. The east bay has a 2/2 double-hung sash with a bullnose-moulded frame. The second story has three new 6/6 sash in bullnose frames. These sash replace the earlier 2/2 sash and were recently installed. There is a one-story, three-bay, shed-roof porch with standing-seam metal and three turned posts. There were originally four, but one was removed. The porch also has jigsaw brackets. There is an interior brick chimney on the northwest end. There is a one-story gable roof addition on the southwest that has aluminum siding and asphalt shingle roof, with a ridge that runs northeast-to-southwest, and a parged foundation. It is a two-bay by two-bay structure and has new 1/1 sash. It also has an exterior brick chimney.
